SELECTED TRANSPORTATION AND INFILTRATION ACTIVITY SOUTHEAST ASIA

NPIC/R-210/66 **JULY 1966**

SUMMARY NO 10

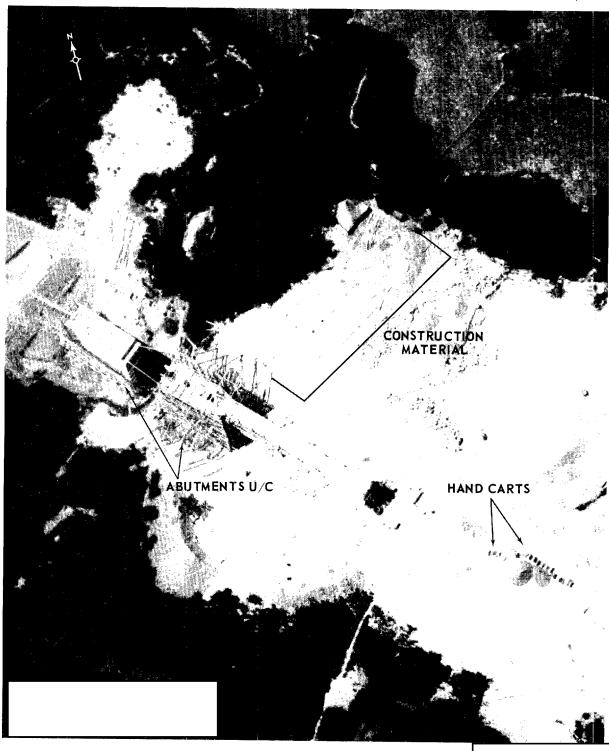
FIGURE 1.A. STANDARD GAUGE RAIL LINE UNDER CONSTRUCTION, NORTH VIETNAM

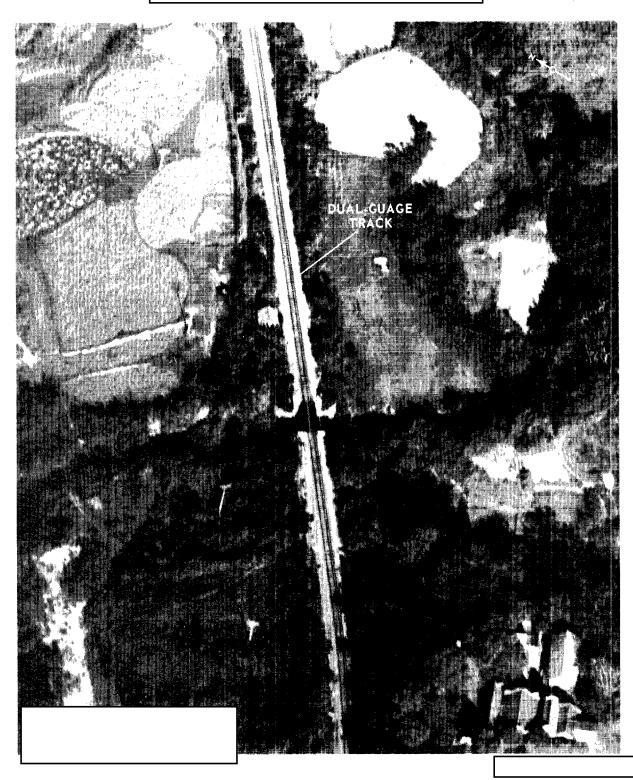
R-210/66	
	25X1C R-210/00	
	1. Dual-gauge Capability, Ha Noi/Ping Hsiang Rail Line	
	A dual-gauge rail line capability (Figure 1B) presently exists on the Ha Noi/Ping Hsiang Rail Line between Cao Nung Railroad Bridge at 21-33N 106-29E and Kep Rail Yard at 21-25N 106-17E. Meter gauge rail lines may be converted to dual-gauge by widening the rail bed and adding a third rail,	7
	permitting utilization of the line by both meter gauge (used in North Vietnam) and standard gauge (used in China) rail cars. The existence of a third rail between the Cao Nung Railroad Bridge and China has not been verified due to a lack of photographic coverage.	•
25X1D	On photography of the dual-gauge rail line was not observed 4.5 nm northeast of Kep at 21-26N 106-21E; however, there was evidence of construction preparation for the addition of a third rail. The rail bed had been widened and improved and standard gauge rail ties had been substituted for the shorter rail ties used for meter gauge lines (Figure 1C). The third rail was in place 9.5 nm northeast of Kep at

FIGURE 1B. DUAL-GAUGE RAIL LINE, NORTH VIETNAM

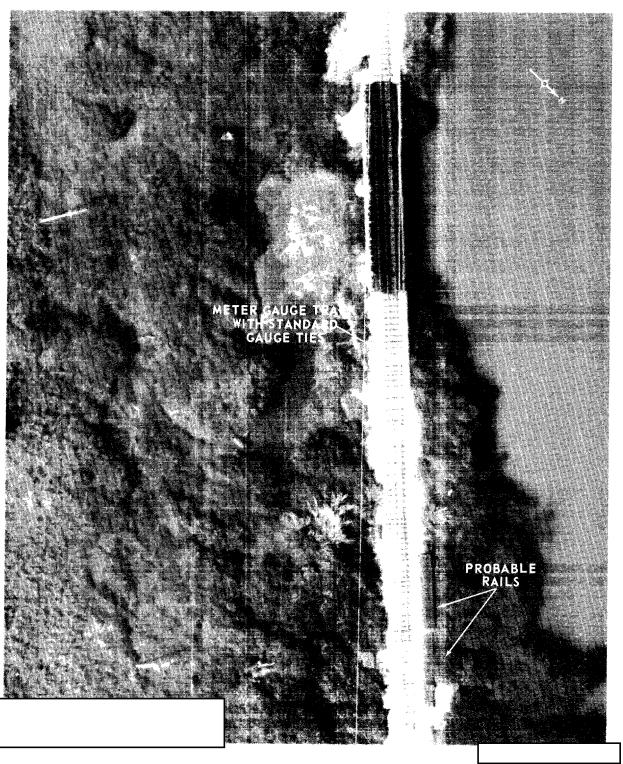
25X1D FIGURE 1C. DUAL-GAUGE RAIL LINE UNDER CONSTRUCTION, NORTH VIETNAM

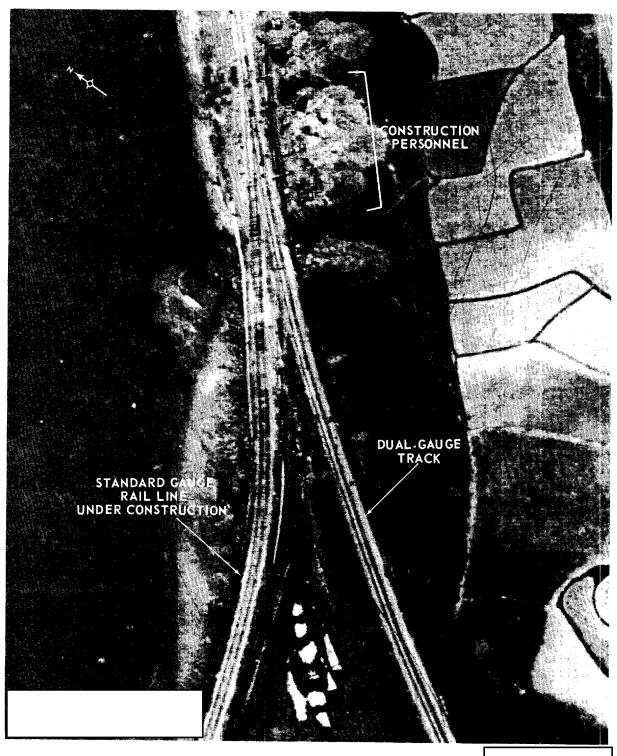
21-30N 106-25E	25X1D
	Construction activity observed south of Kep indicates the probable extension of the dual-gauge capability to Ha Noi. A work train discharging ballast was observed at 21-19N 106-15E (Figure 1E) and standard gauge rail ties were observed at 21-16N 106-10E (Figure 1F) and at 21-20N 106-15E. Undistributed ballast has been observed piled at numerous places in this area.	
	A rail line is under construction between Kep and the Thai Nguyen Ore Processing Plant rail line (Figure 1A). The junction of this line with the Ha Noi/Ping Hsiang Rail Line at 21-25N 106-18E (Figure 1D) was observed on photography and only standard gauge track was observed in this area.	25)

FIGURE 1D. DUAL-GAUGE RAIL LINE, NORTH VIETNAM

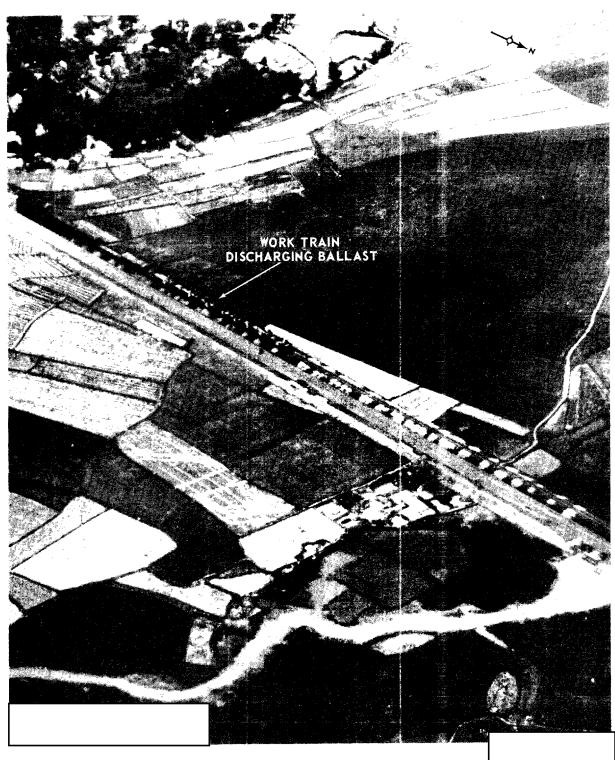
FIGURE 1E. PROBABLE DUAL-GAUGE RAIL LINE UNDER CONSTRUCTION, NORTH VIETNAM

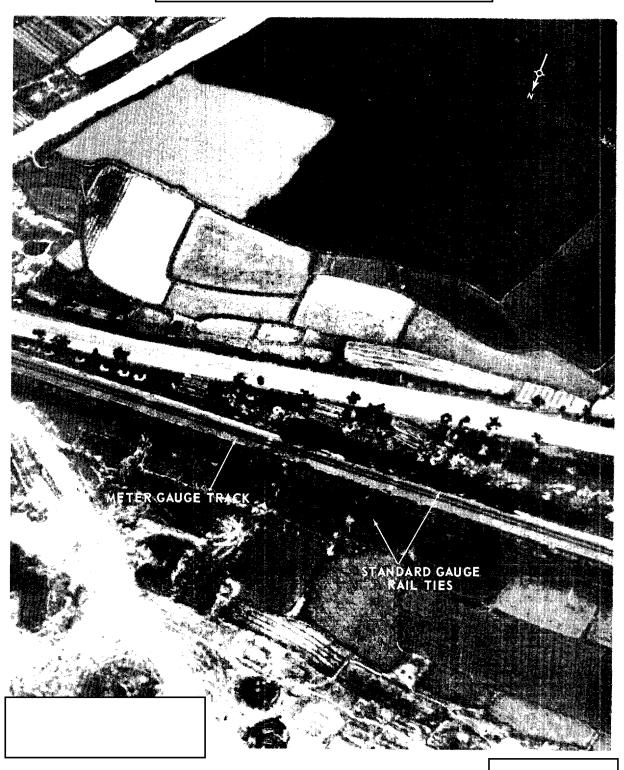
FIGURE 1F. PROBABLE DUAL-GAUGE RAIL LINE UNDER CONSTRUCTION, NORTH VIETNAM

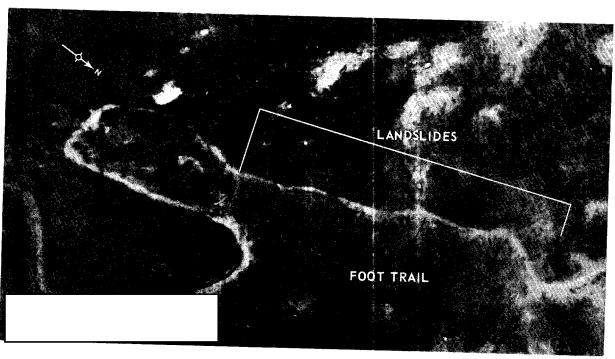
FIGURE 4. LANDSLIDES, ROUTE 96, LAOS

Route 96 is unserviceable at 15-25N 107-00E. Landslides have rendered approximately 350 yards of the road, from UTM YC149062 to 149065 (Figure 4), impassable for vehicular traffic; however, a well-used foot trail extends along the road alignment. Weathering has caused the road embankment to collapse at UTM YC147069, rendering that point of the road also impassable.
